JOHN C. SMITH DAM

NDI ID NO. 238

PHASE I INSPECTION REPORT.

D'APPOLONIA CONSULTING ENGINEERS  
10 DUFF ROAD  
PITTSBURGH, PA. 15235  
SEPTEMBER 1978

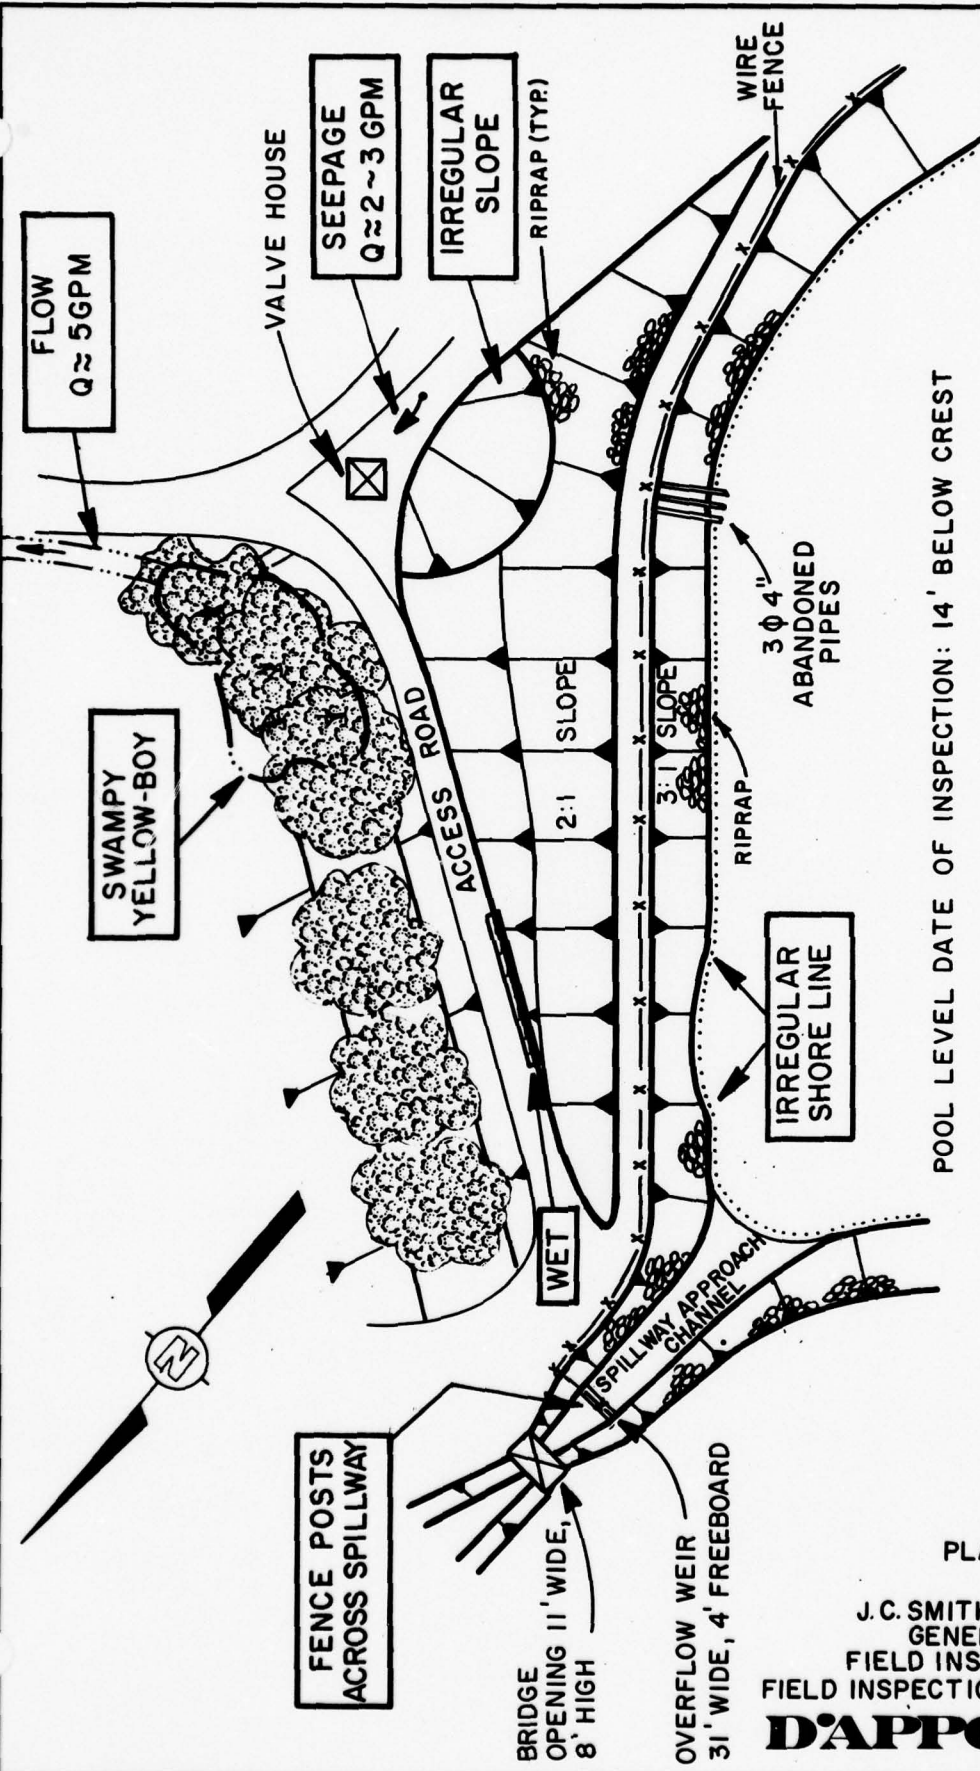
PLATE 6

VISUAL EXAMINATION OF	OBSERVATIONS	REMARKS OR RECOMMENDATIONS
JUNCTION OF EMBANKMENT AND ABUTMENT, SPILLWAY AND DAM	No signs of distress or seepage observed. It is reported that there is a seepage around the left abutment when the pool level is within 4 to 6 feet of spillway crest level.	
ANY NOTICEABLE SEEPAGE	Two seeps at toe level. See Plate 6 for location.	
STAFF GAGE AND RECORDER	None	
DRAINS	None

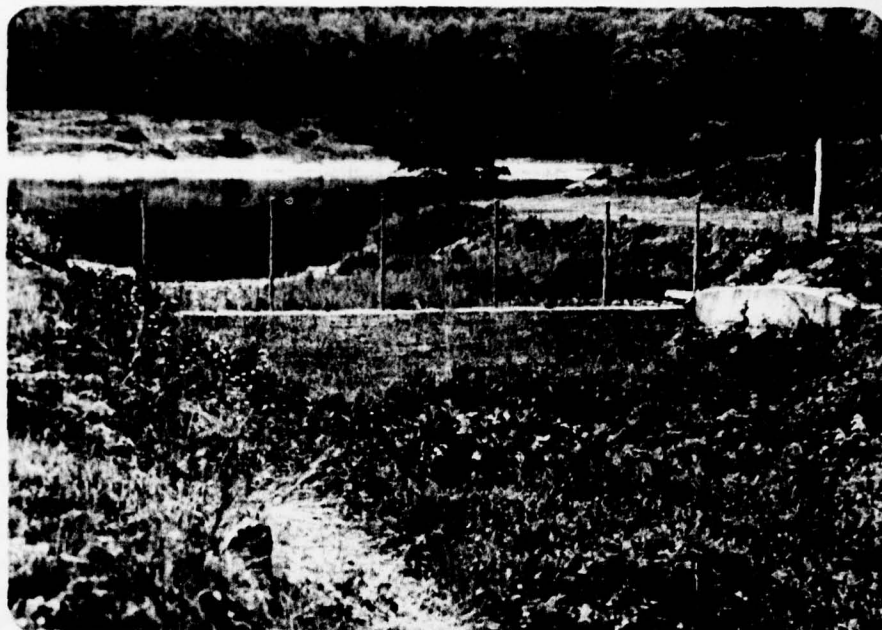
The most significant condition at the dam is found to be potential blockage of the spillway with debris due to the presence of a barbed wire fence across the spillway crest and a small bridge spanning the spillway discharge channel.

Photograph No. 3  
Spillway crest.

c. Urgency. Necessary studies and improvements required to provide sufficient spillway capacity should be implemented immediately. The barbed wire fence across the spillway crest should also be removed immediately. Other recommendations should be continued on a continuing basis or as soon as practicable.

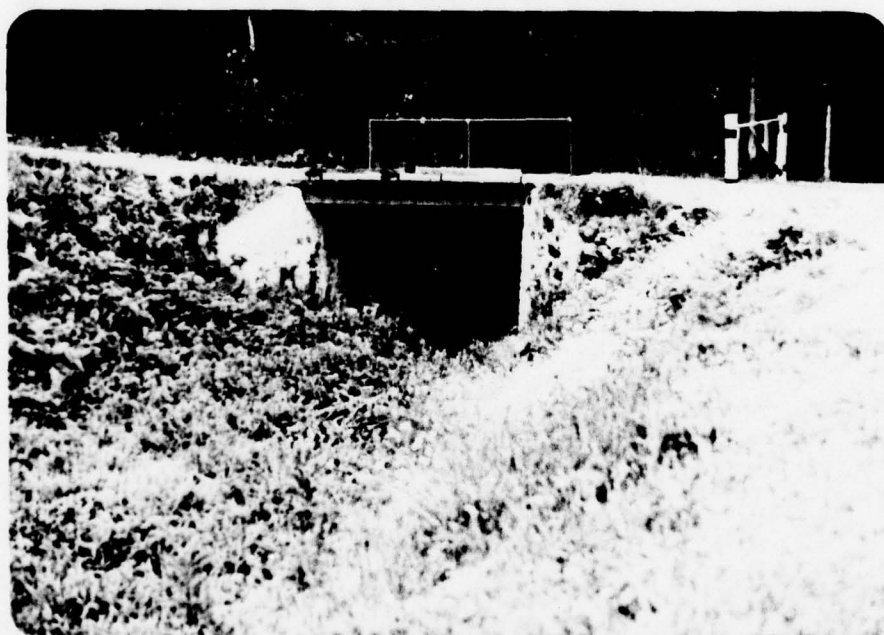
VISUAL EXAMINATION OF	OBSERVATIONS	REMARKS OR RECOMMENDATIONS
CONCRETE WEIR	Concrete overflow section. There is a barbed wire fence across the spillway crest.	
APPROACH CHANNEL	Trapezoidal riprapped channel	
DISCHARGE CHANNEL	Natural ravine	
BRIDGE AND PIERS	There is a bridge across the discharge channel of the spillway approximately 50 feet downstream from the crest of the spillway.	This bridge constitutes a potential for blockage of the spillway.

Photograph No. 4  
Bridge over spillway discharge channel  
(about 50 feet downstream from the  
spillway crest).

The barbed wire fence across the crest of the spillway and the bridge across the discharge channel are considered to pose a potential for blockage of the spillway with debris in the event of a flood. It is therefore recommended that the barbed wire fence be immediately removed and the need for enlarging the bridge span should be investigated.

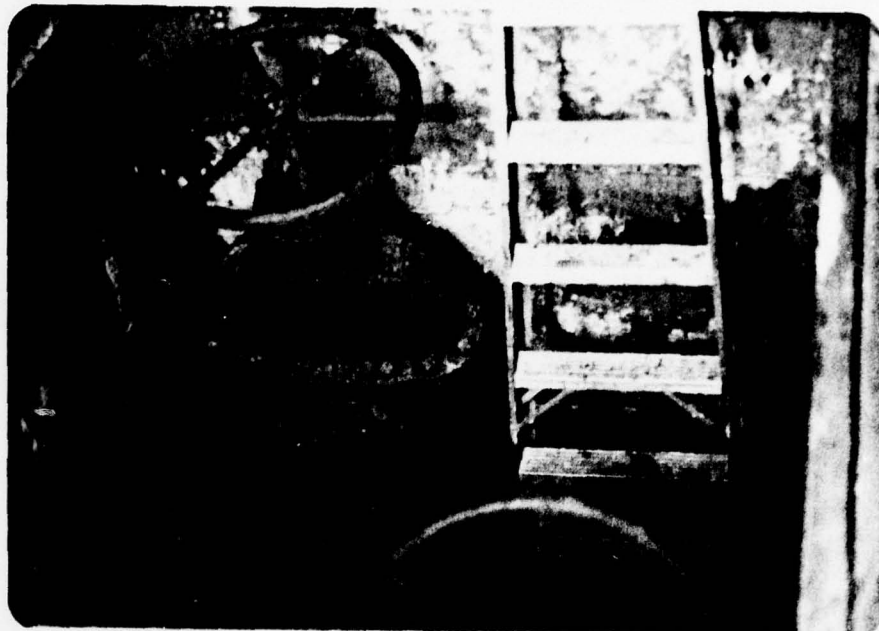
4.3 Maintenance of Operating Facilities. The maintenance condition of the operating facilities is considered to be fair. The operation of the blow-off valve was not observed. However, subsequent to the field inspection, borough personnel reported that the blow-off valve was operated and observed to be functional. Borough personnel reported that one of the three abandoned steel pipes located on the upstream face of the dam contains the stem of the upstream control valve for the outlet pipe. However, no hoist mechanism exists for this gate and it is reported that it has not been operated in the recent past.

Photograph No. 5  
Outlet pipe valve at valve house.

3. The owner should take necessary steps to repair the valve located on the upstream end of the drainpipe.
4. In view of the reported seepage condition through the left abutment, it is recommended that further studies be undertaken to assess the effect of this seepage condition on the performance of the embankment, in the event it is required to raise pool level above the normal pool elevation (approximately Elevation 1330) that has existed in the recent past.

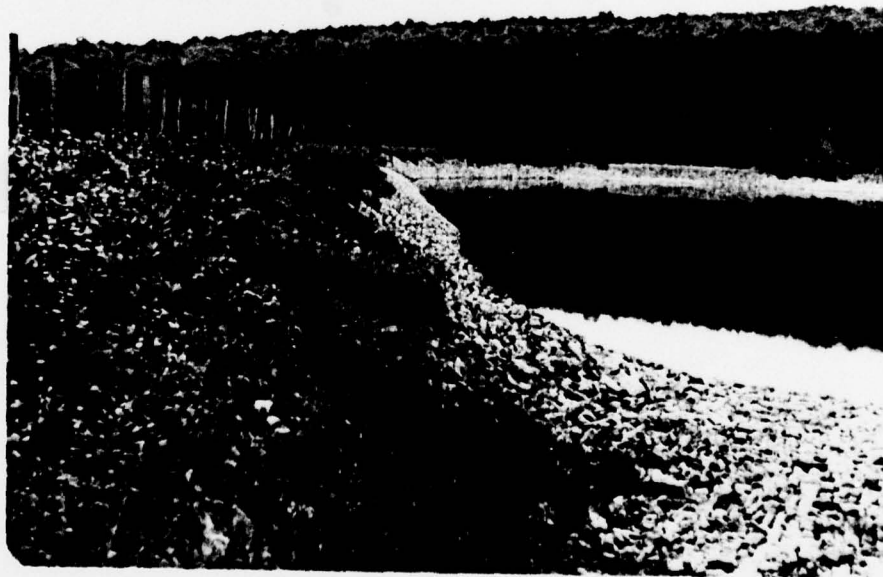
VISUAL EXAMINATION OF	OBSERVATIONS	REMARKS OR RECOMMENDATIONS
SURFACE CRACKS	None found	
UNUSUAL MOVEMENT OR CRACKING AT OR BEYOND THE TOE	A general depression exists on the upstream face near the spillway approach channel. However, no signs of distress were observed.	
SLOUGHING OR EROSION OF EMBANKMENT AND ABUTMENT SLOPES	None found	
VERTICAL AND HORIZONTAL ALIGNMENT OF THE CREST	No perceivable misalignment	
RIPRAP FAILURES	None

Photograph No. 6  
Minor depression on upstream face.
